INTRAORAL REPAIR IN METAL-CERAMIC PROSTHESES: A CLINICAL REPORT.

REPARO INTRAORAL DE PRÓTESES METALO -CERÂMICAS : UM RELATO DE CASO CLÍNICO .

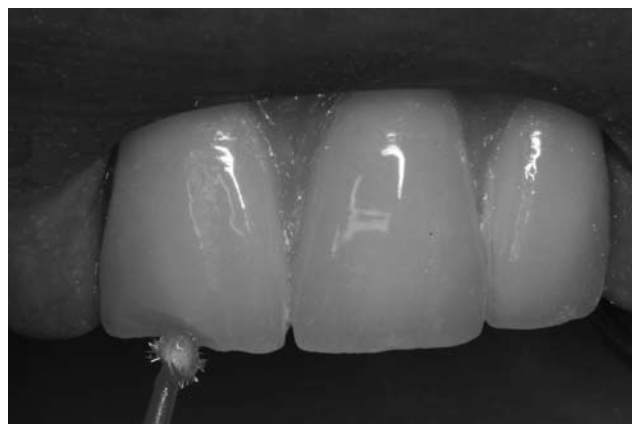
Fig. 4 – Application of the silane agent RelyX Ceramic Primer (3M ESPE)

4) Applied the silane RelyX® Ceramic Primer (3M ESPE, Seefeld -Germany), allowing 60 seconds for drying (Figure 4)

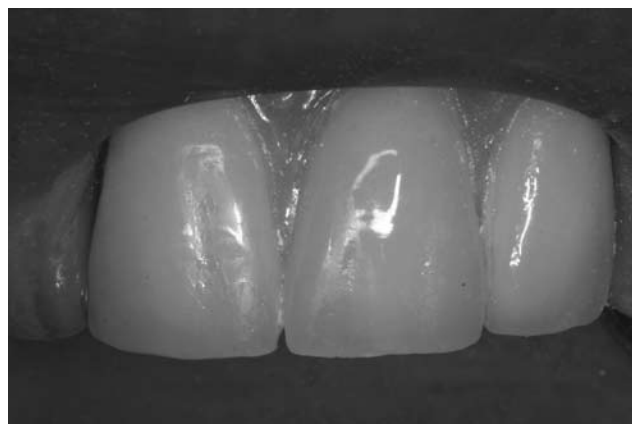
Fig. 5 – Applied composite resin Z100.

6) Applied the composite resin Z100 – Incisal Shade (3M ESPE, St. Paul - USA), incisal color, using an incremental technique (Figure 5)

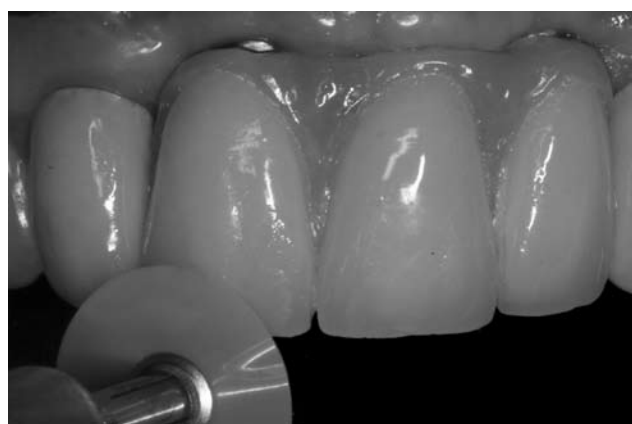
Fig. 6 – Use of the Soflex (3M) disk sequence for finishing and polishing.

After one week, the patient returned to the Dental School to carry out finishing and polishing procedures on the restoration (Figures 6 and 7). The final aspect of the restoration is illustrated in Figure 8.

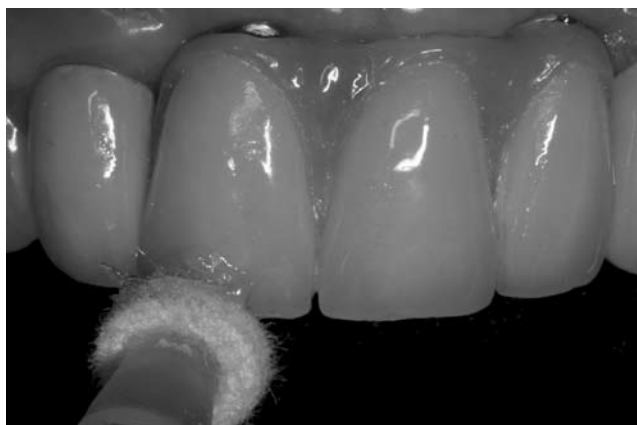
Fig. 7 – Use of gel for polishing

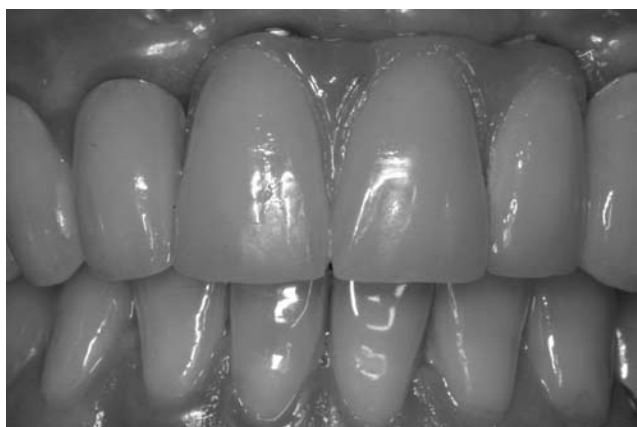
Fig. 8 – Final view of the intraoral repair
